historic structure report  
architectural data section  
volume 1  
june 1985

HISTORIC STRUCTURE REPORT

Architectural Data Section

LINDENWALD

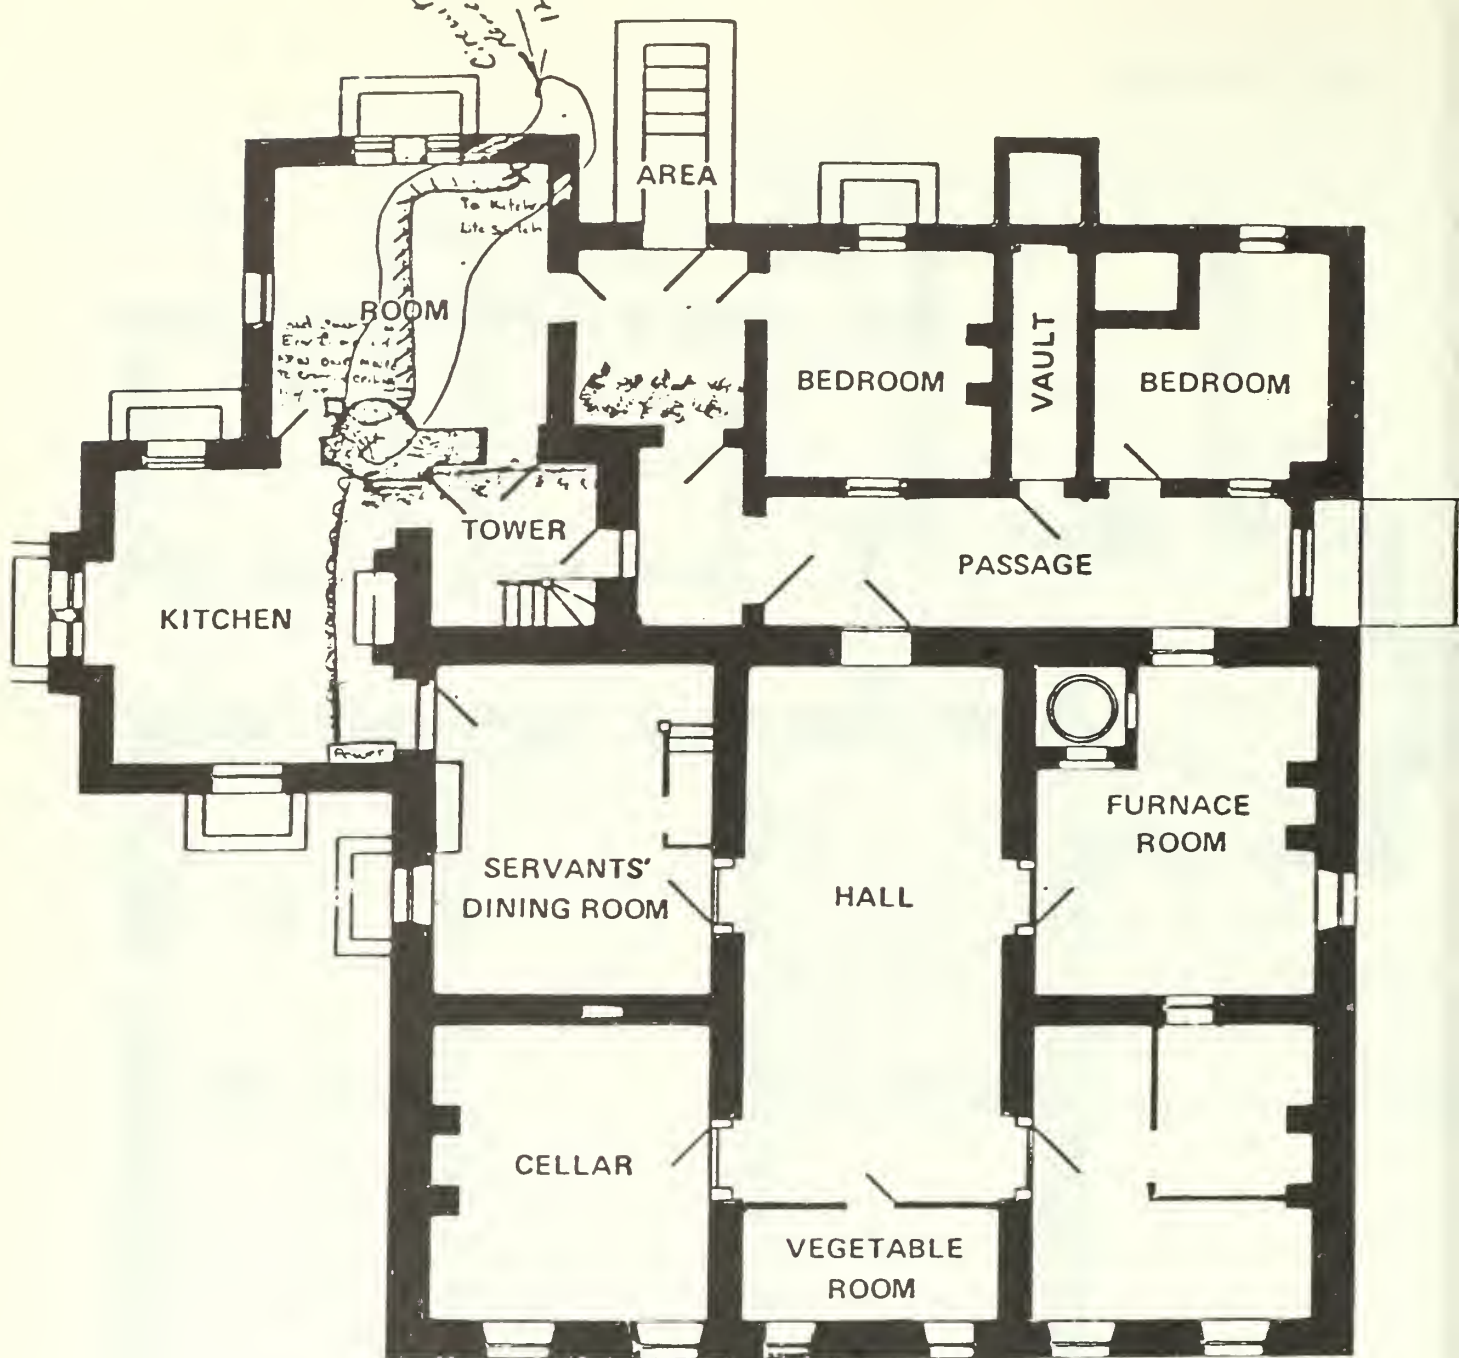
*all circuits in Box 2 grounded  
9 wires to area, two of the wires find  
to overhead switch in Box and from there  
all lines are new. 11/2/77 A.R.*

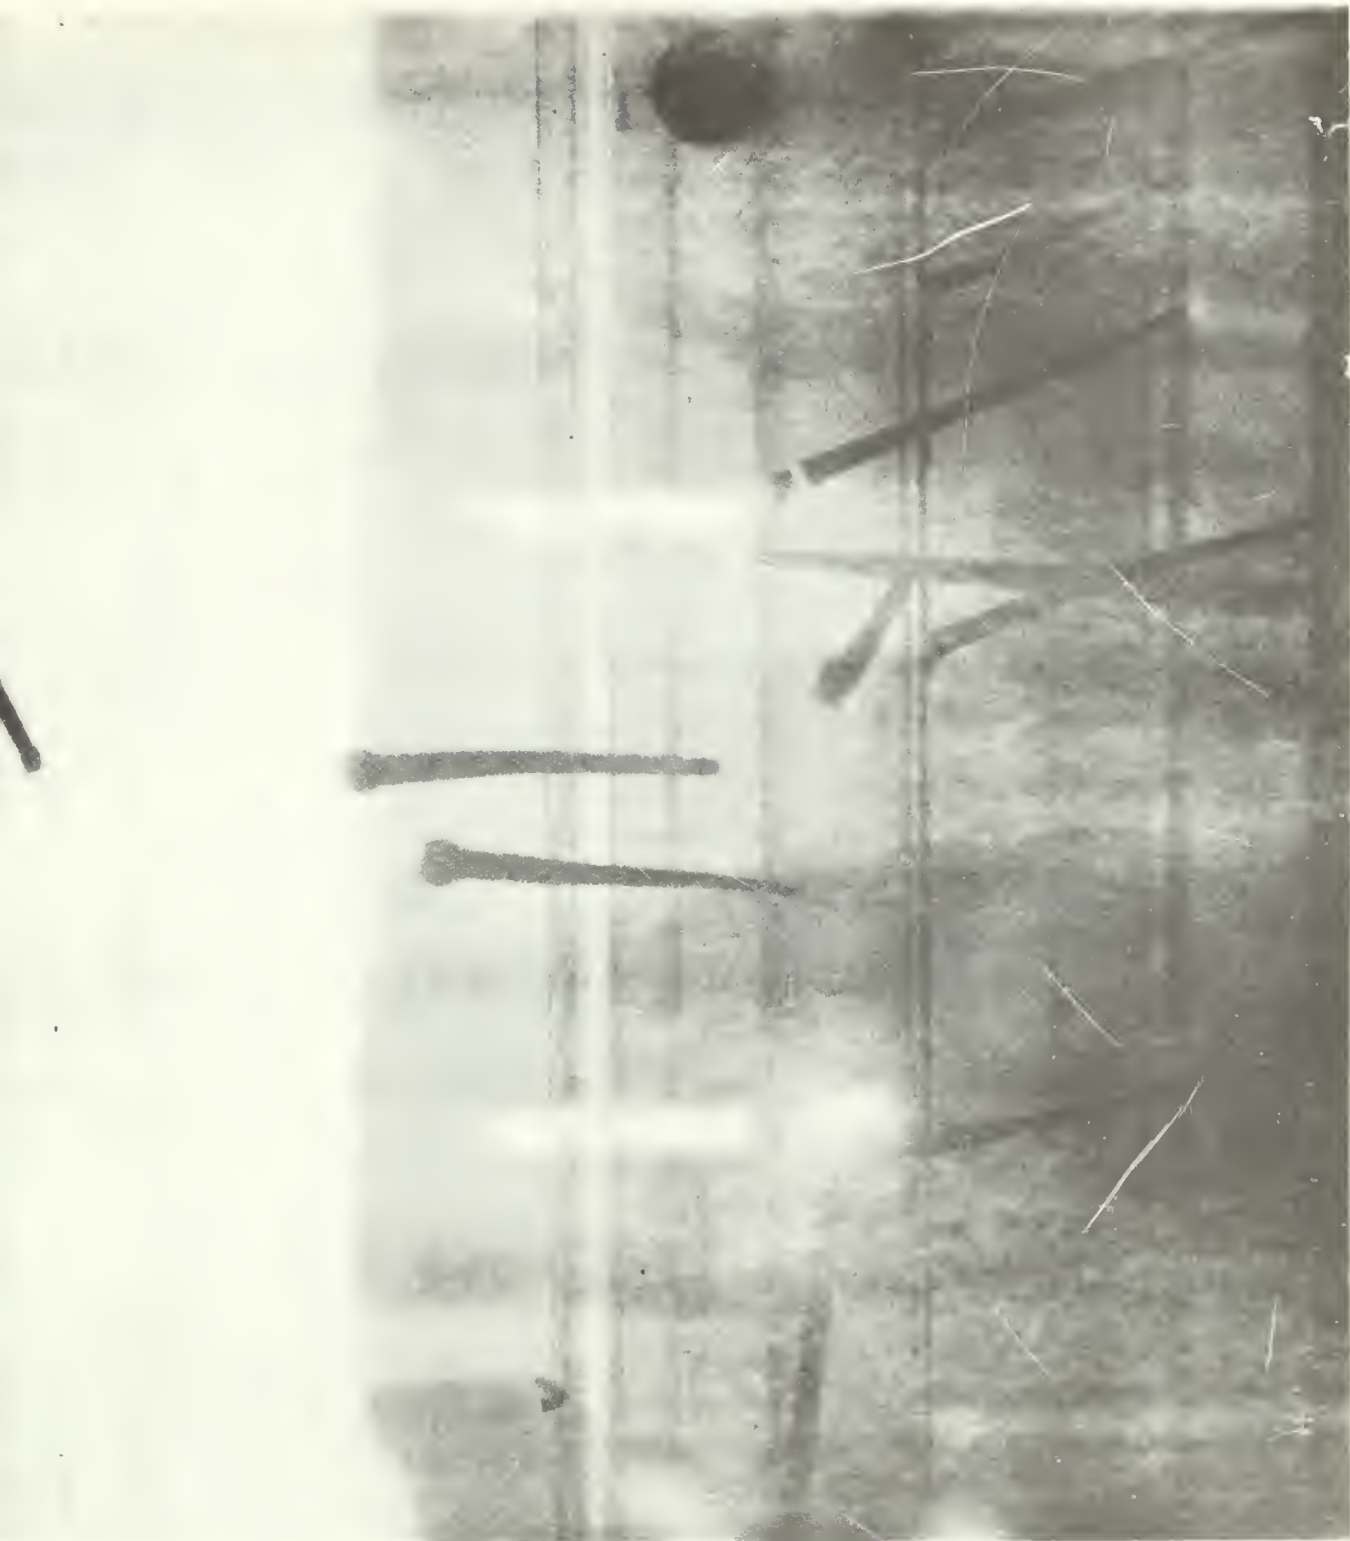
MAVA 01 X001

Room 105, south wall, east jamb of door 130, looking south 36" above the floor.

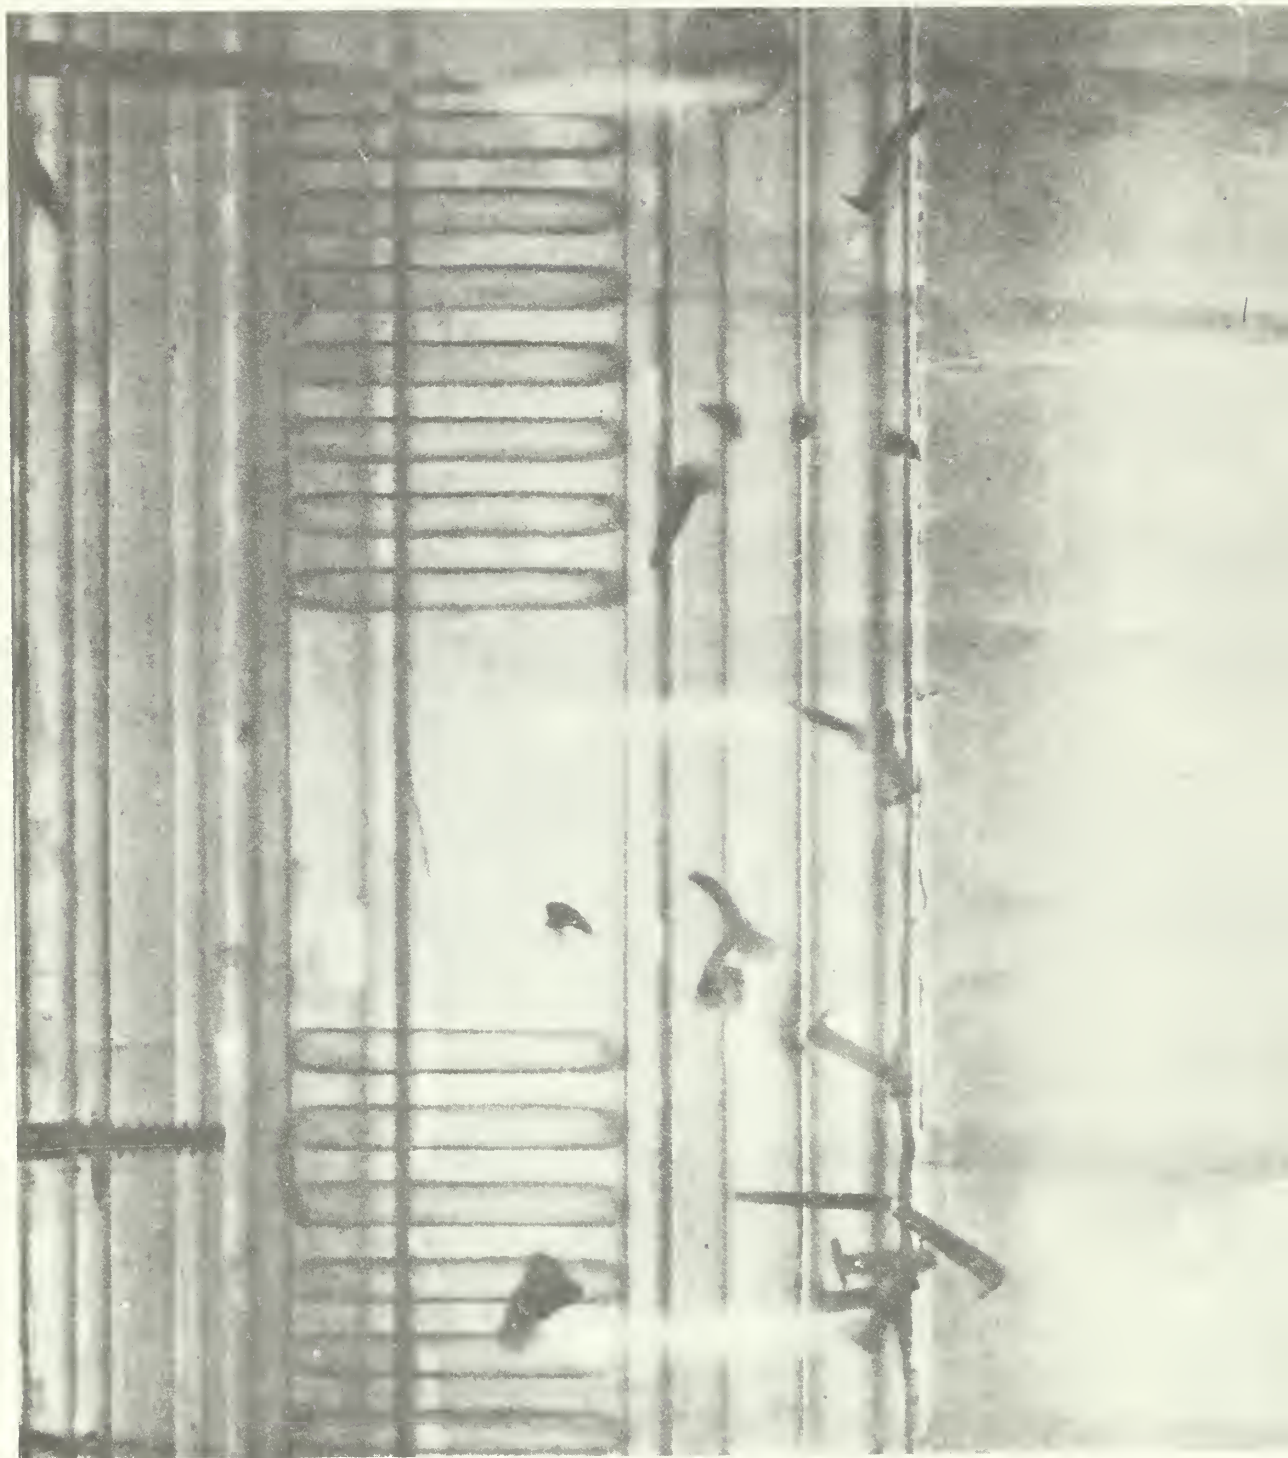
MAVA 01 X002

Room 106, door 136, east jamb, looking north 3'4" above the floor.

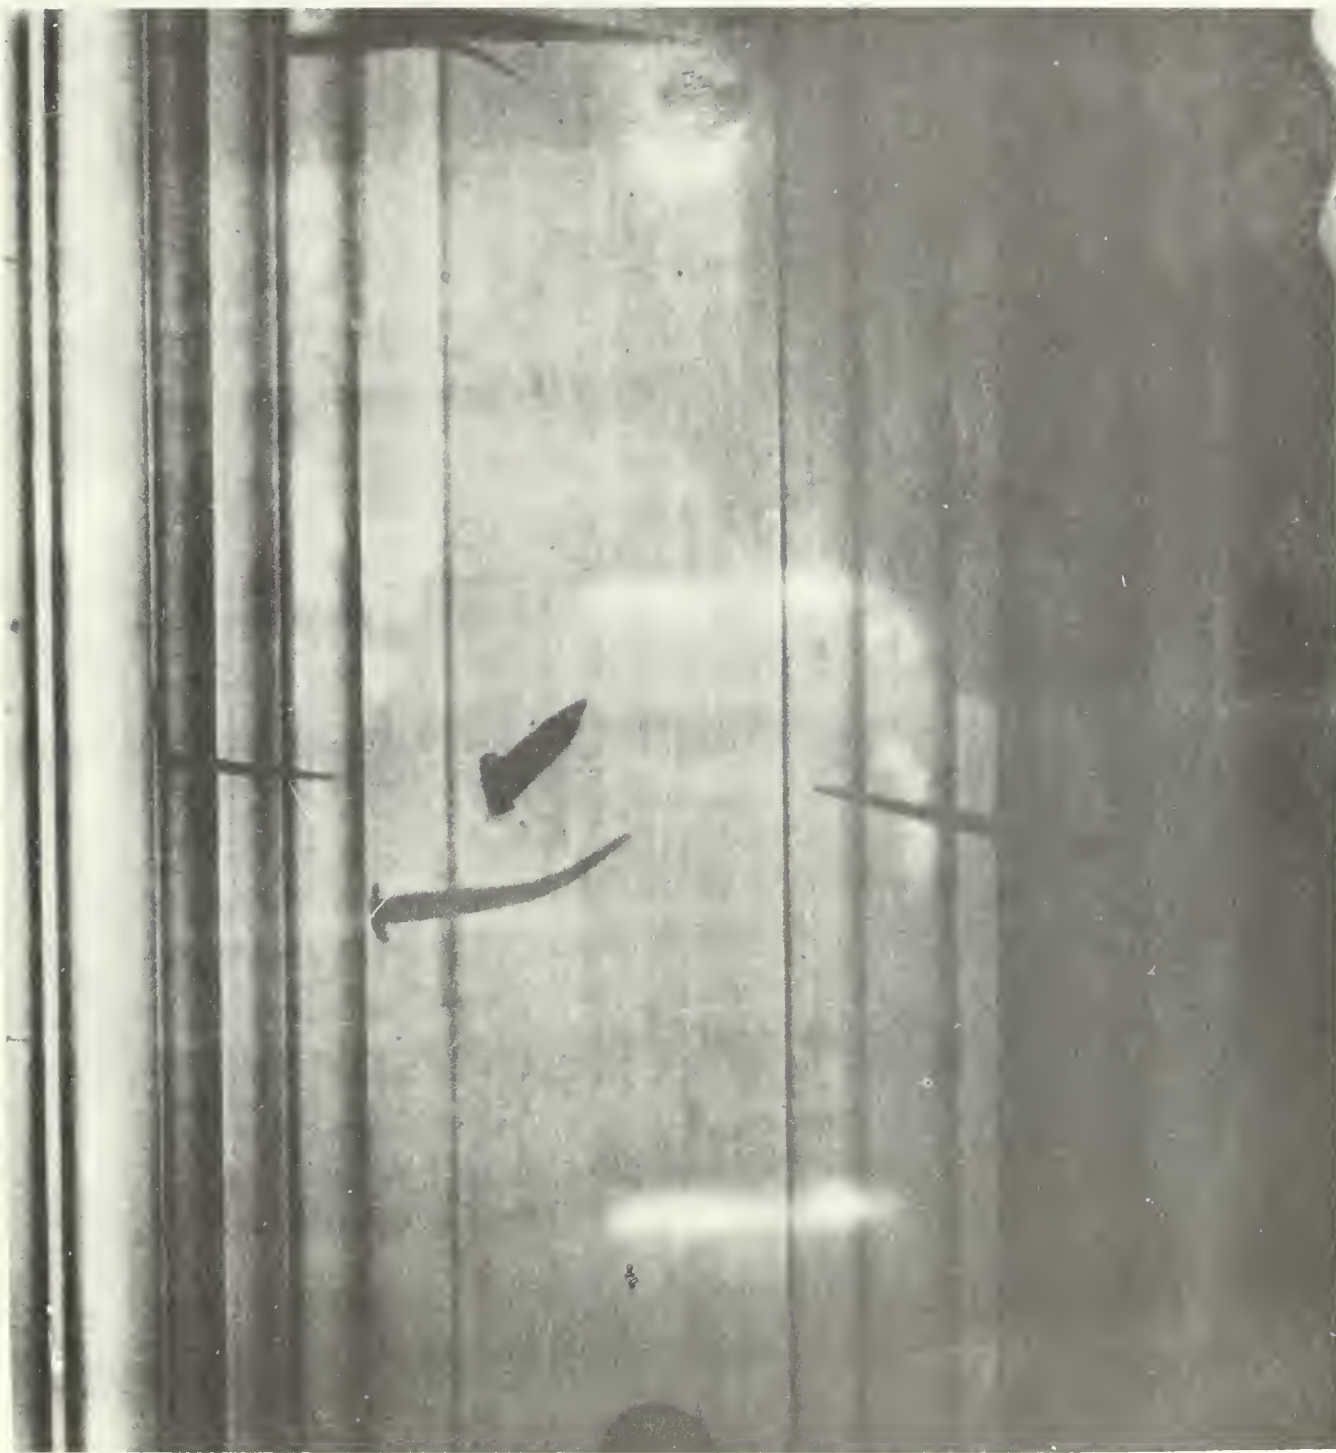
MAVA 01 X003

Room 106, west wall, looking west 3'4" above the floor.

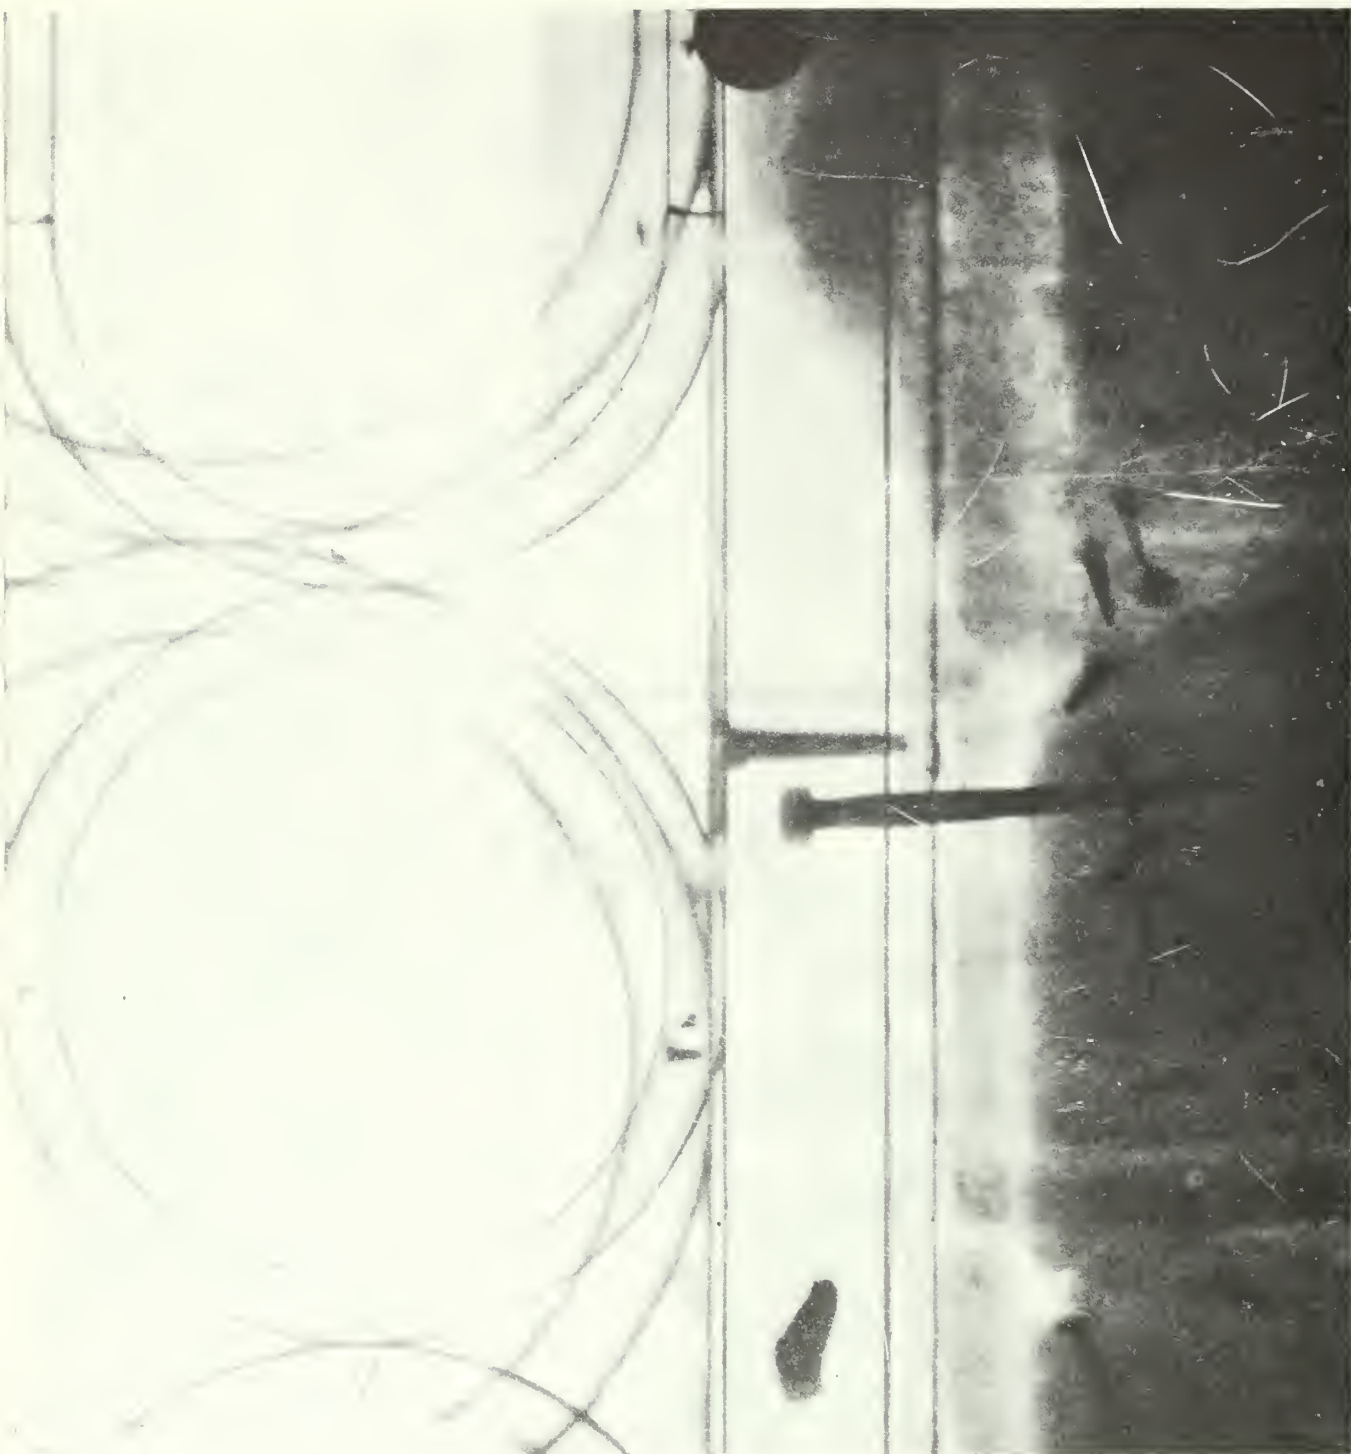
MAVA 01 X004

Room 206/207, door 218, north pilaster, looking west 2'10" above the floor.

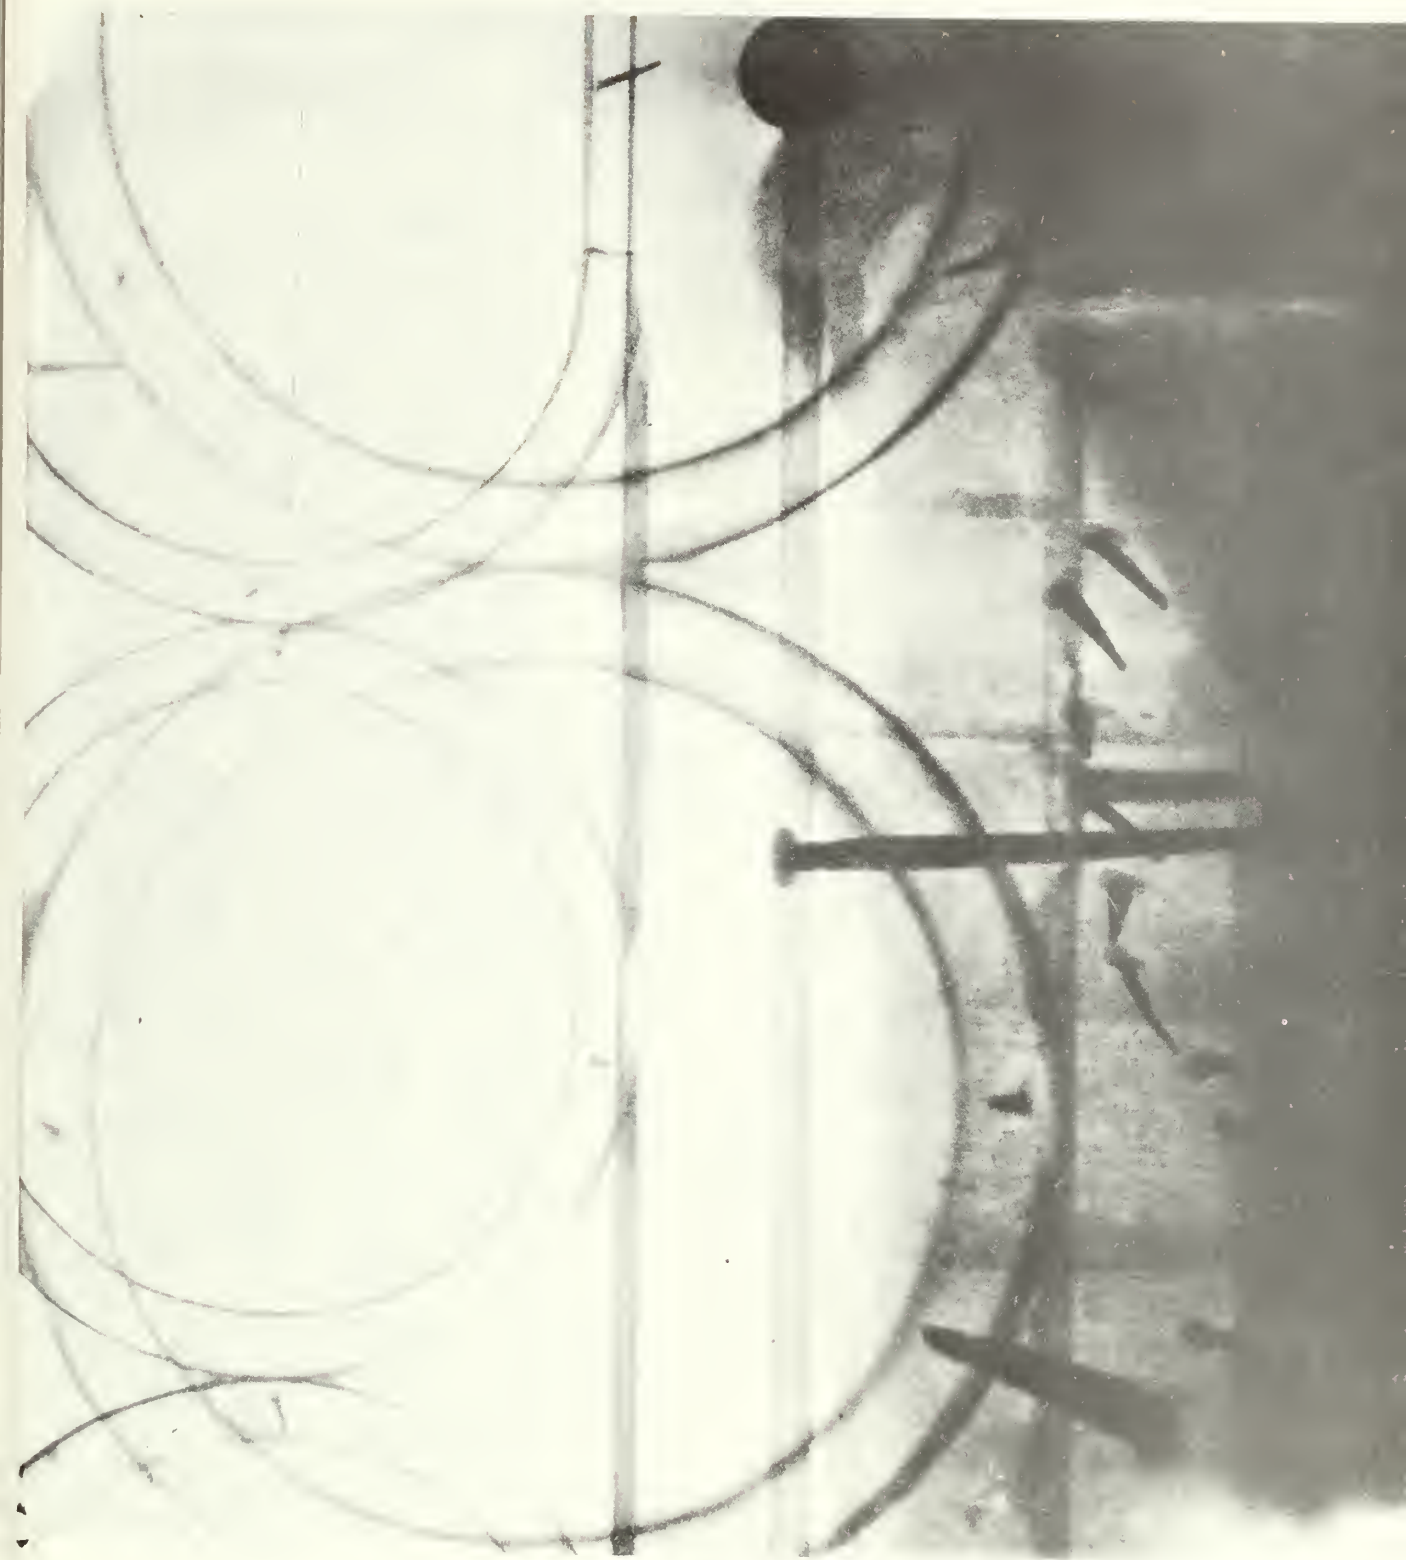
MAVA 01 X005  
Room 206/207, door 218, north pilaster, looking west 2'10" above the floor.

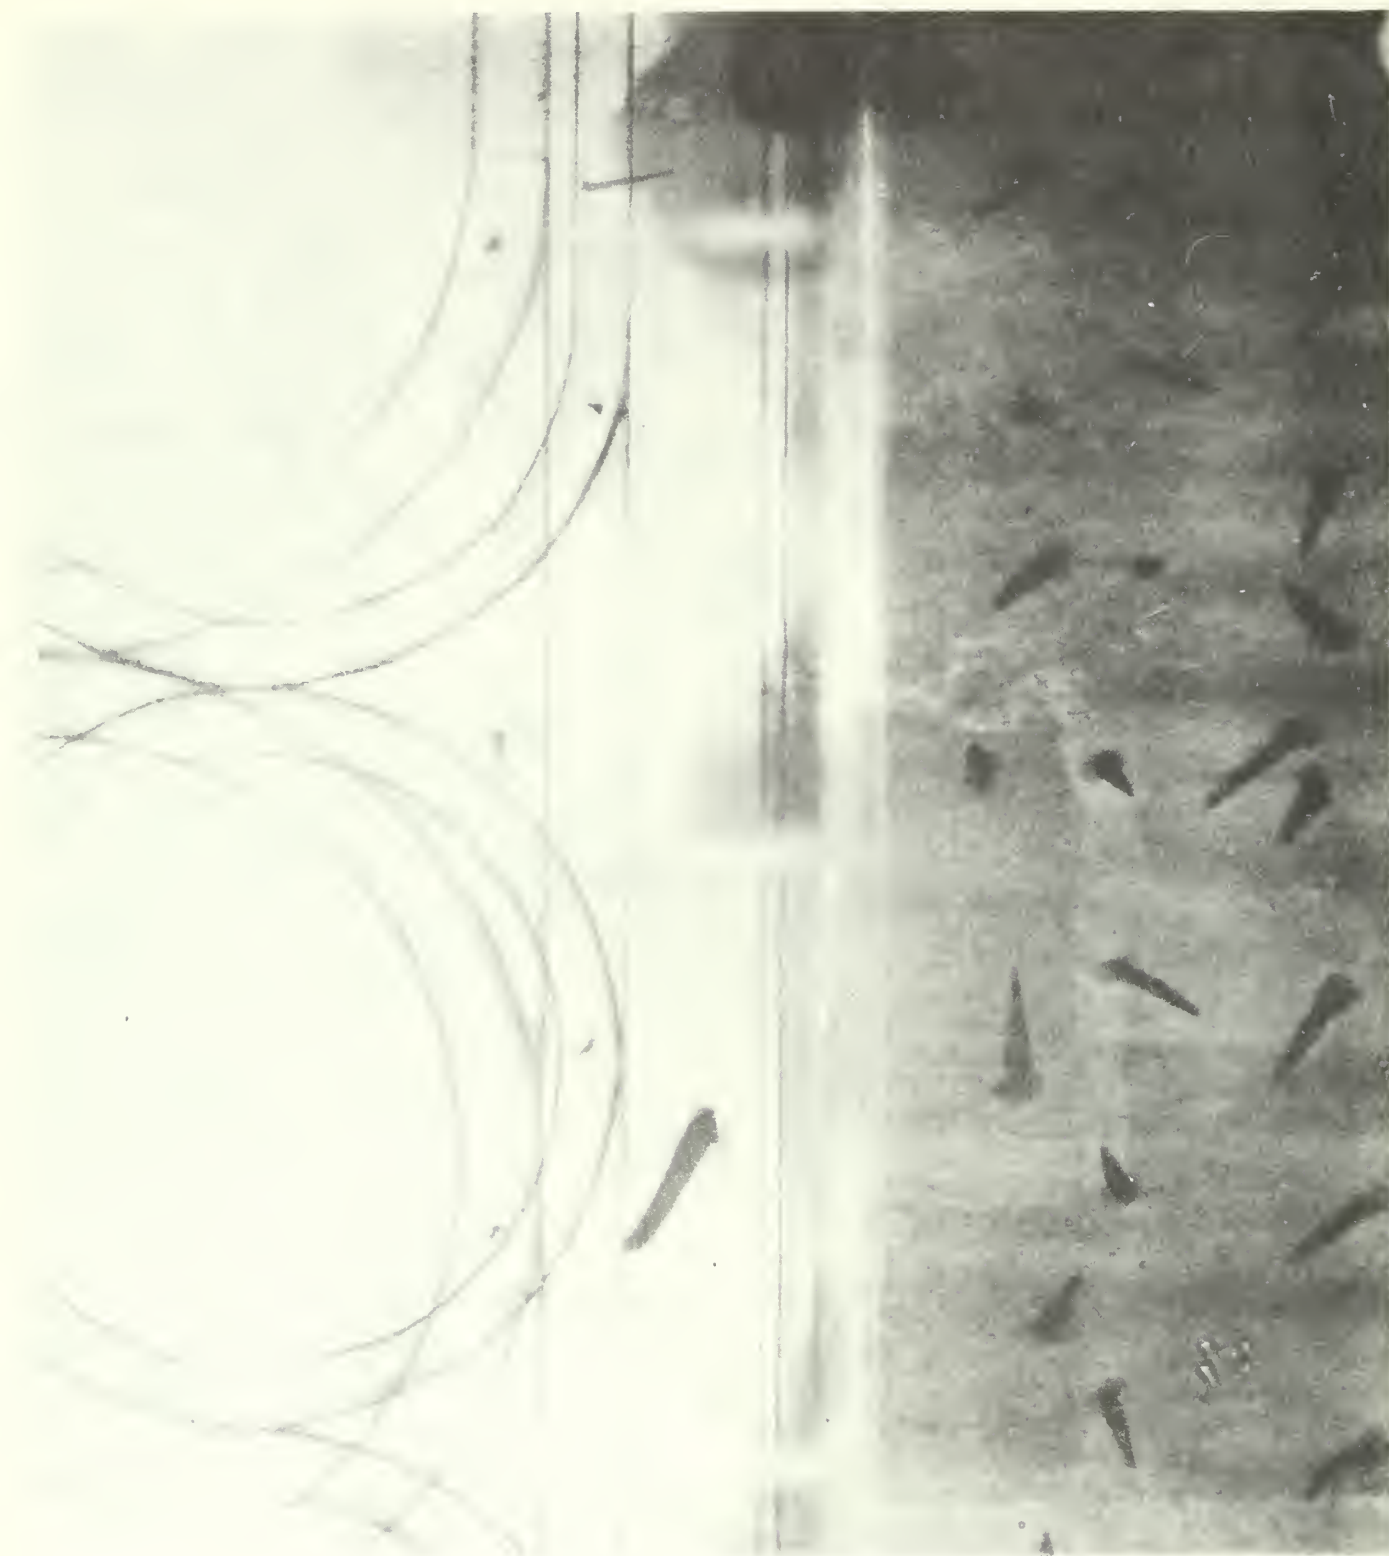
MAVA 01 X006

Room 206/207, door 218, south pilaster, looking east 2'10" above the floor.

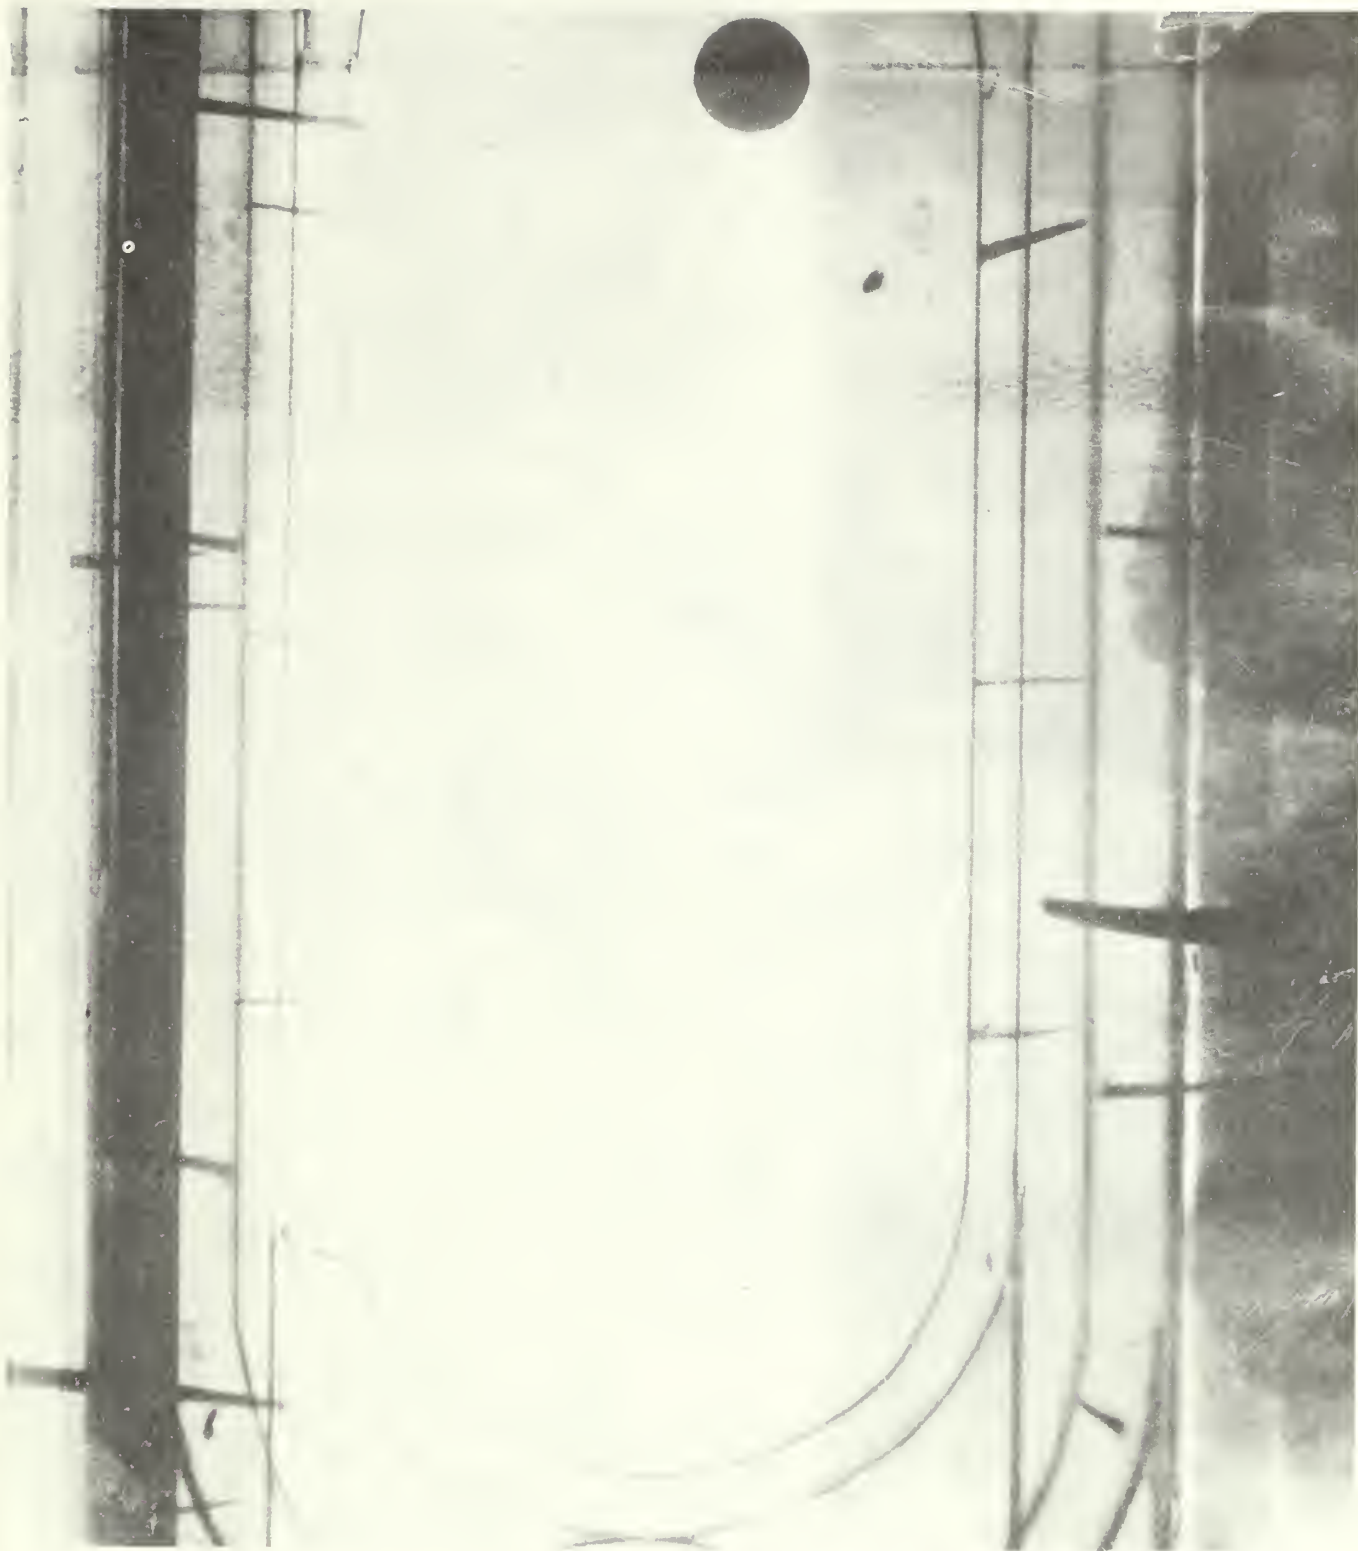
MAVA 01 X007

Room 206/207, door 218, south pilaster, looking east 2'10" above the floor.

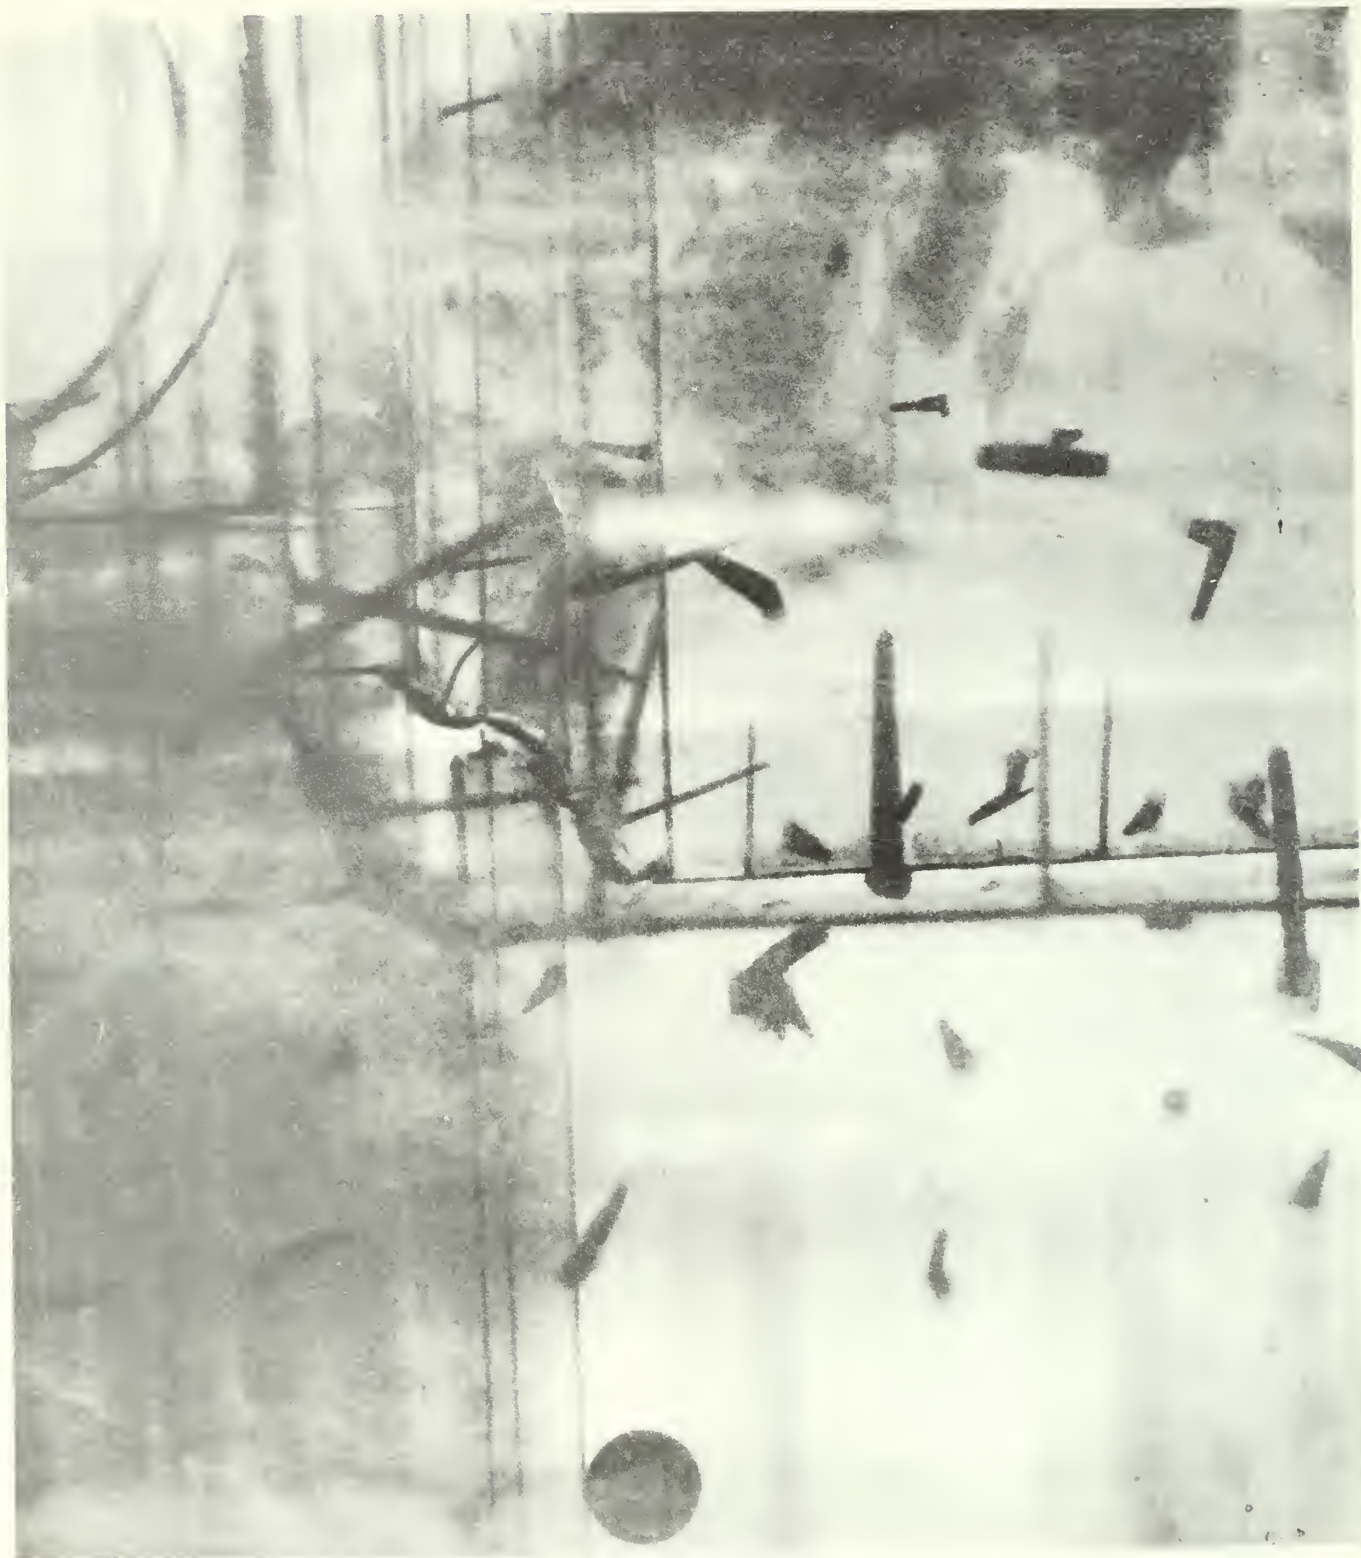
MAVA 01 X008

Room 206/207, door 218, south pilaster, looking west at floor level.

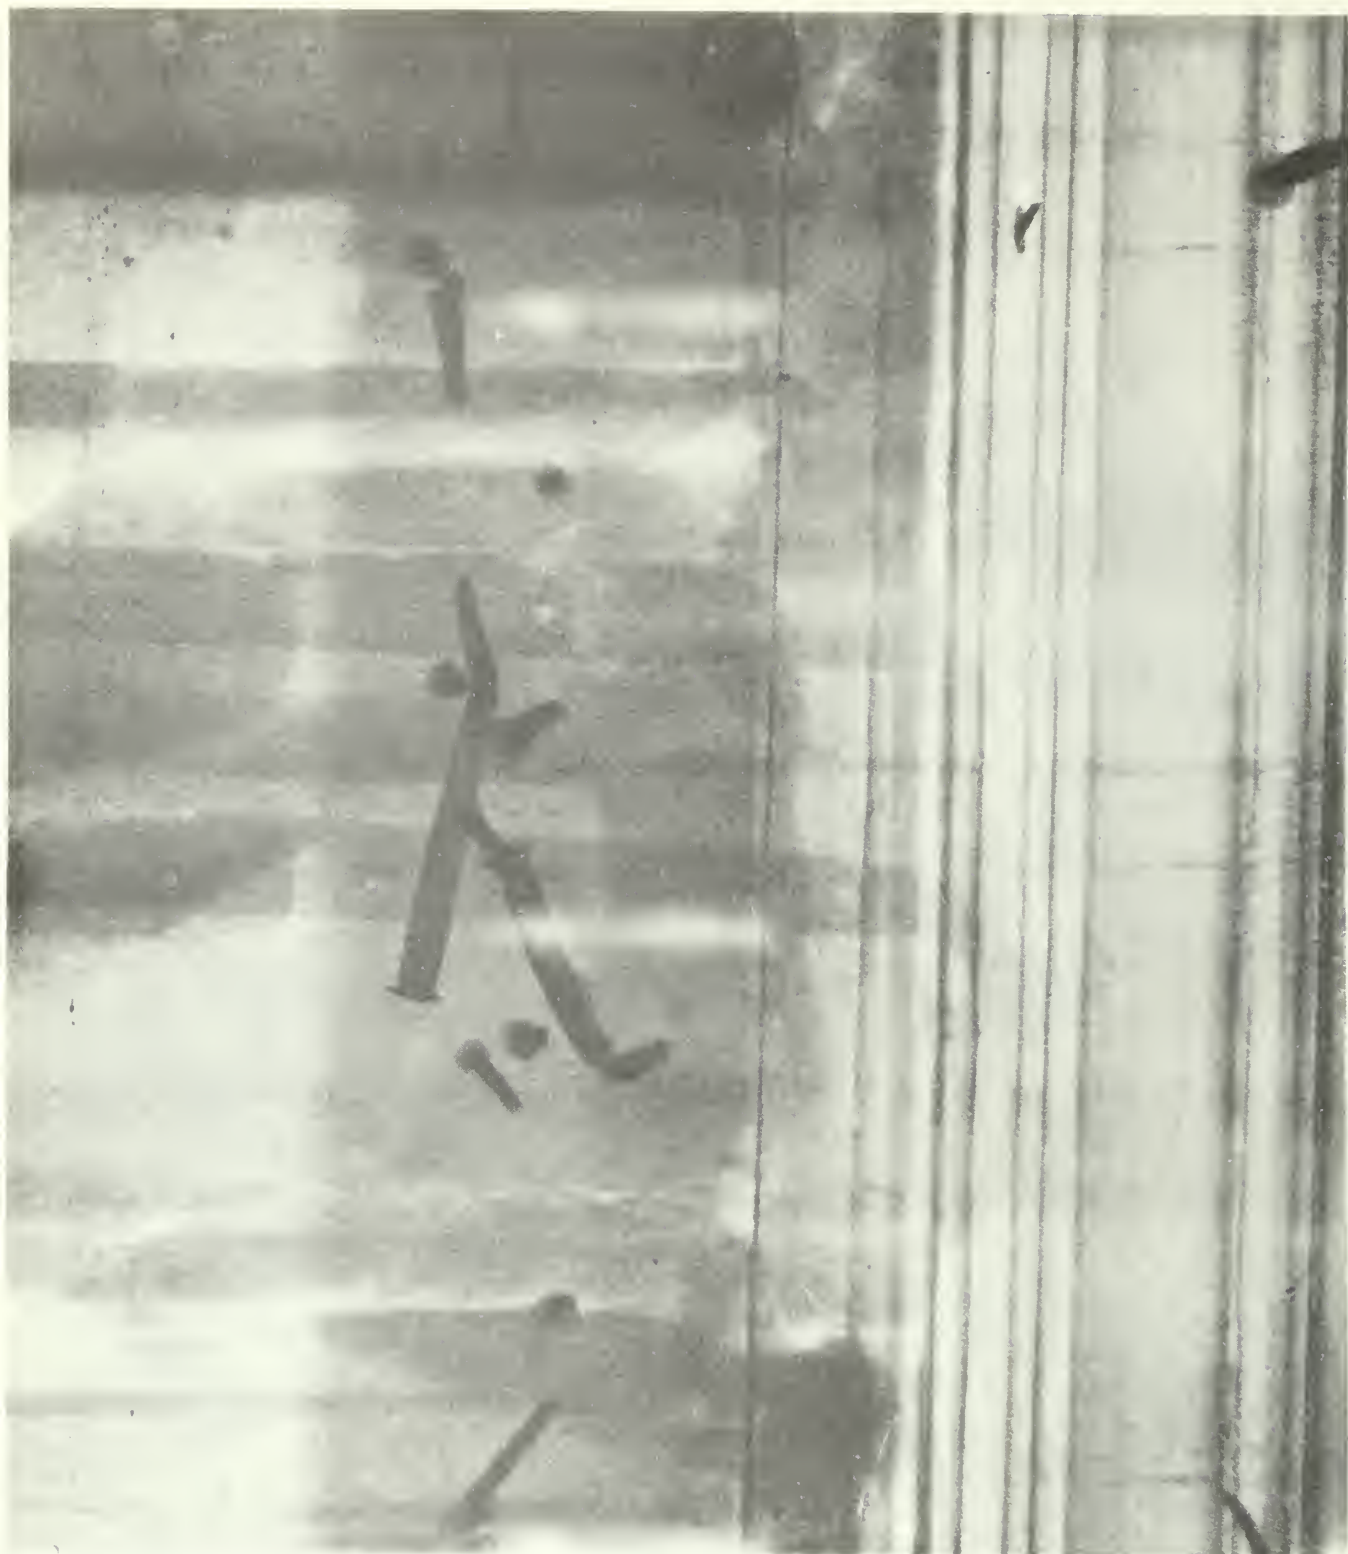
MAVA 01 X010

Room 207, door 202, north jamb, looking east 2'10" above the floor.

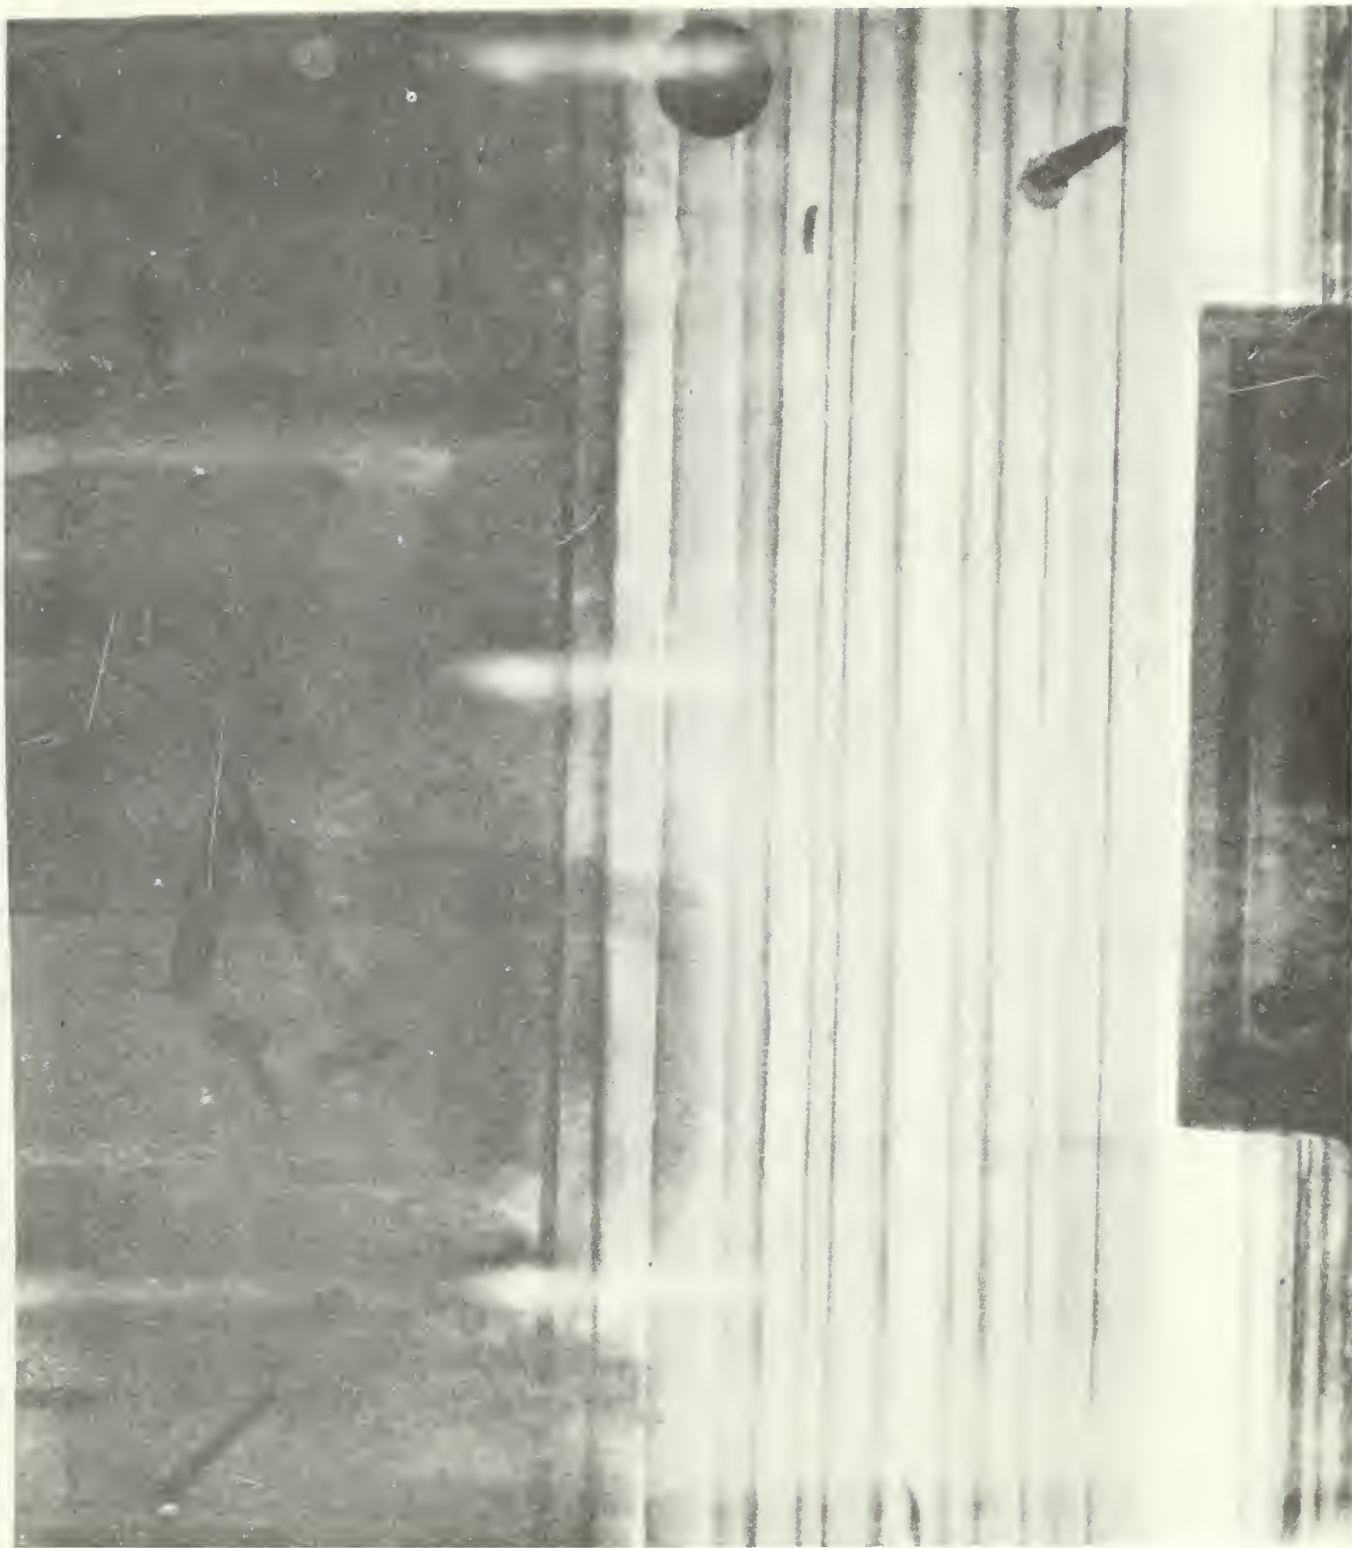
MAVA 01 X011

Room 207, door 202, north jamb, looking east 2'10" above the floor.
